Home Inspection Report

1542 Your Street, Your Town, MD 21701

Monday November 4, 2019

ALL YOURS HOME INSPECTION LLC
494 Windemere Dr.
Aberdeen, MD 21001
443-601-9715
ALLYOURSINSPECTIONS@GMAIL.com

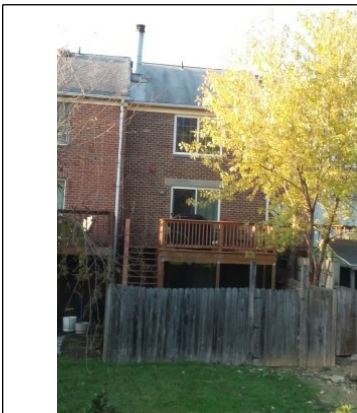
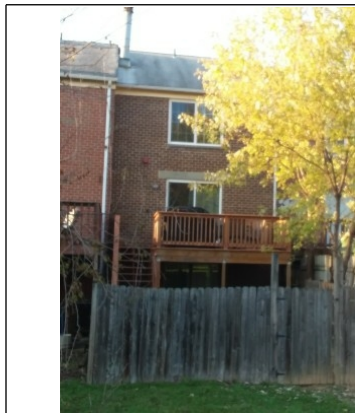
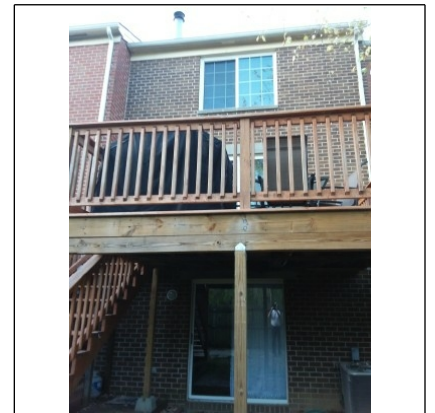
Comments While deck is in otherwise good condition, it was noted that the ledger board is not properly flashed and/or sealed to prevent moisture penetration. Additionally, it was noted that vents from the ground floor are discharging immediately on to the decking. See photos.

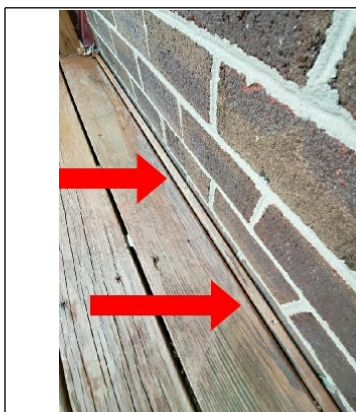
Vents discharging approx 2" from deck surface

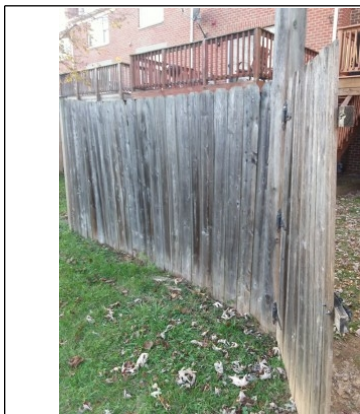
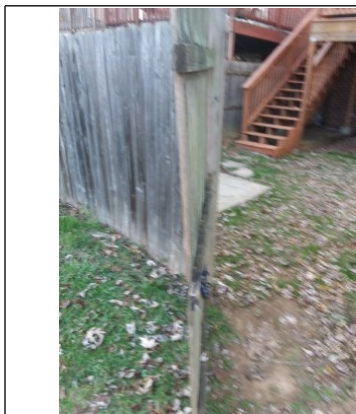
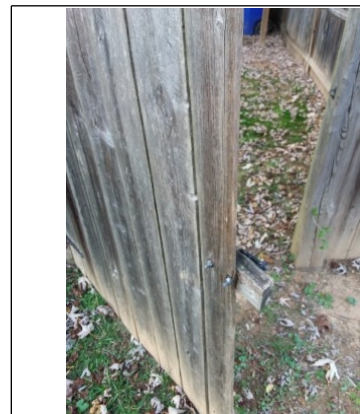
Fencing was in need of maintenance repairs. Gate is functional but needs repairs.

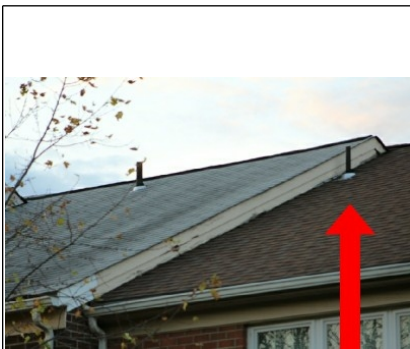
Central plumbing vent with multiple branches later found inside attic.

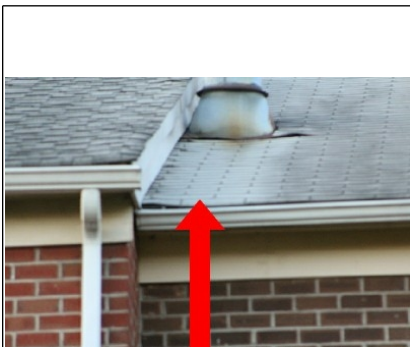
Comments Roof has several areas where wear, age, and damage are visible. Most notably, the rear East side at the meeting of the neighboring unit. There's a distinct line of curling shingles beginning at the fireplace flue and extending to the edge of the roof. There is evidence of moisture penetration at this point in the attic, and below that point in the ceiling of the master bedroom. See photos.

Evidence of prior leak and repair.

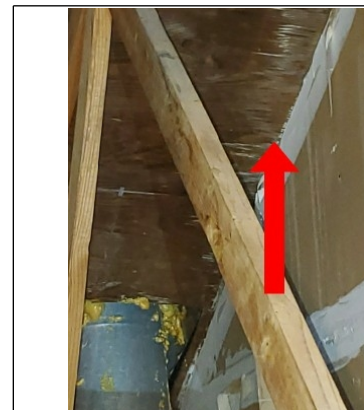
Inside damage noted from prior leak

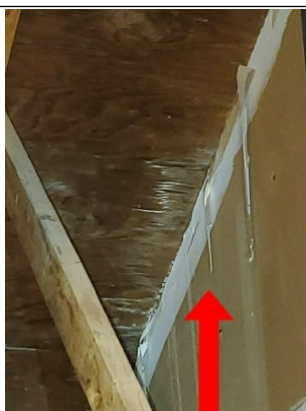
Roof: Shows evidence of leakage on Southwest side. This carries through to Underlayment sheathing visible in attic and interior ceiling visible in MASTER bedroom. Recommend further review by a qualified contractor.

Area below curling shingles in attic

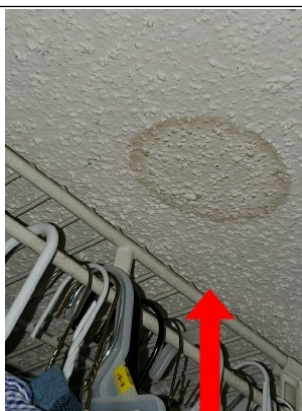
Following the leak, areas below moisture penetration in attic

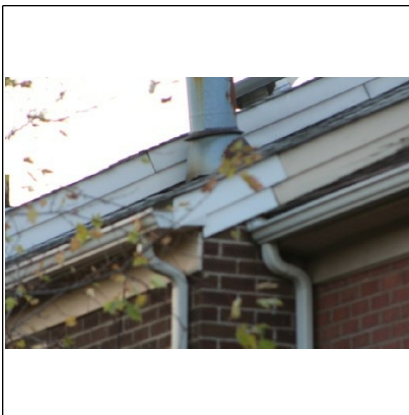
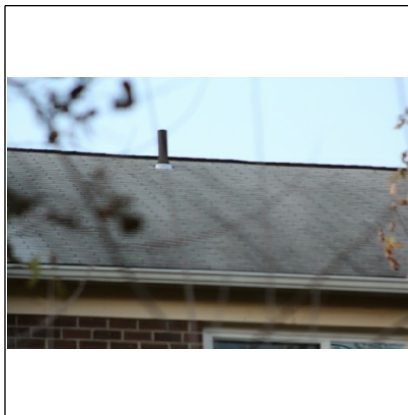
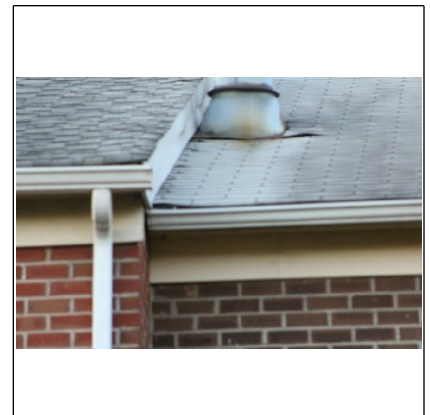
Comments Gutters appear fully functional with no evidence of failures. Downspout extensions at rear of house need reattached. There is evidence of water accumulation at the rear if the house from downspouts. The gutter joint at The southeast corner of the house shows evidence of a prior repair.

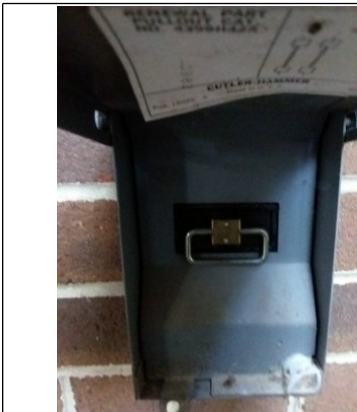
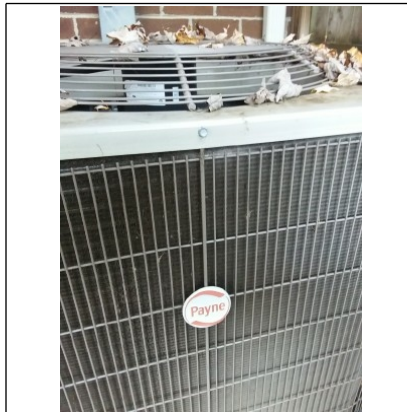
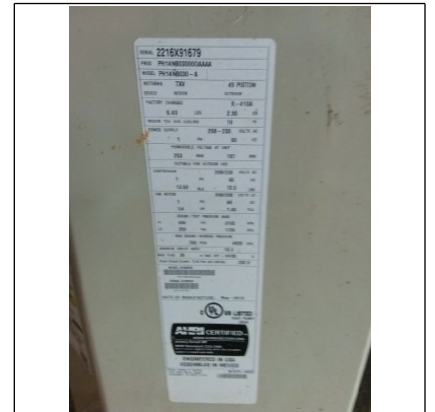
- Insulation** ☒ Yes ☐ No ☐ Replace
- Improper Clearance (air flow)** ☐ Yes ☒ No
- Comments** Unit appears in rough shape for its apparent age. Cabinet is dented, suggesting purchase of a used or damaged piece given its age. Suspect water hitting it from roof / downspout. Unit is not level due to erosion from downspout.

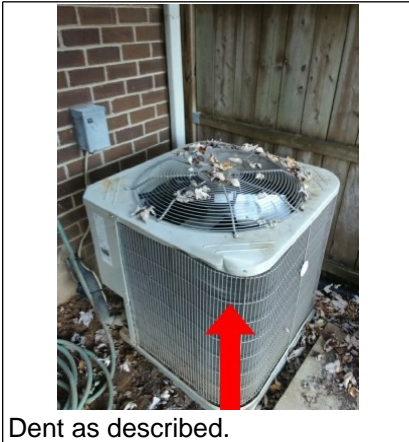
Dent as described.

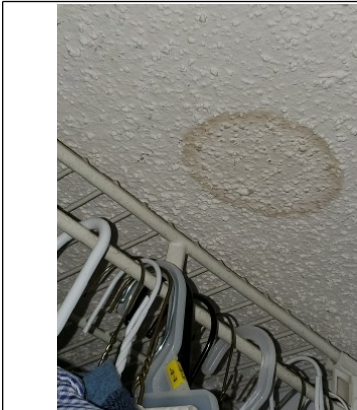
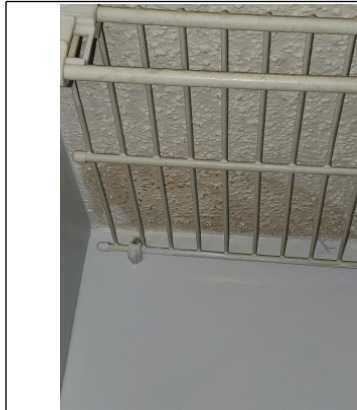
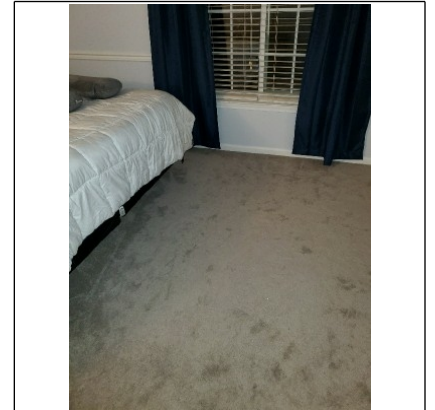
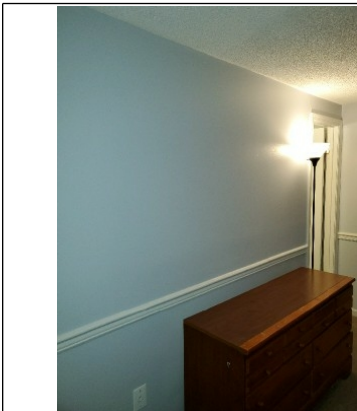
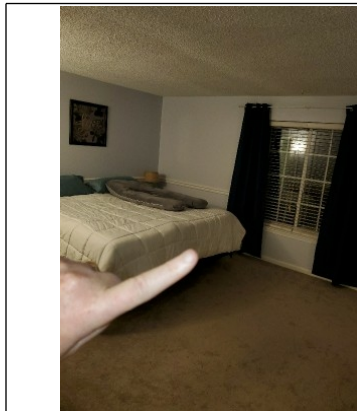
Comments Moisture stains in right hand closet ceiling as described in other section.

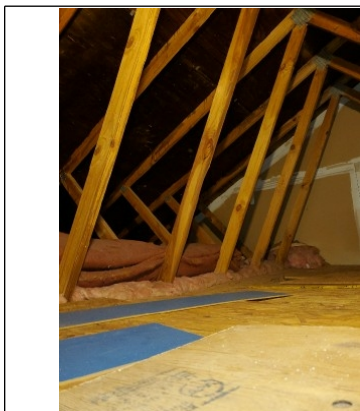
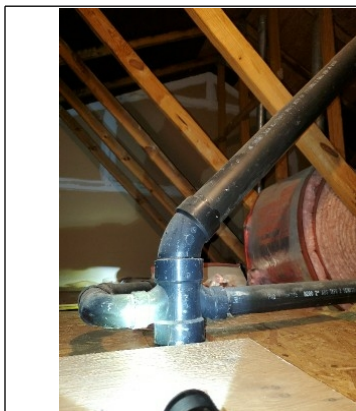
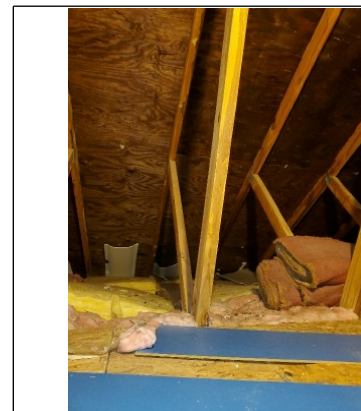
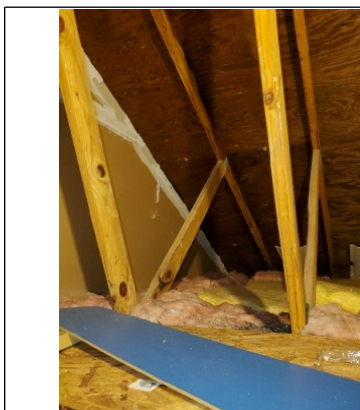
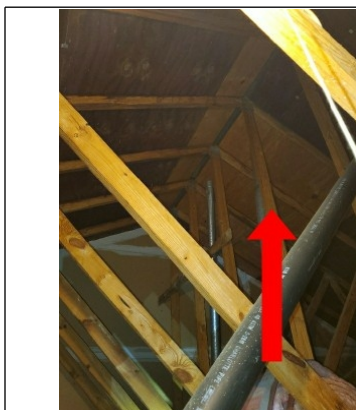
Comments Further attic photos in reference to leaks are in roof section. Roof sheathing shows multiple areas of prior repairs. Noted foaming applied around fireplace flew.

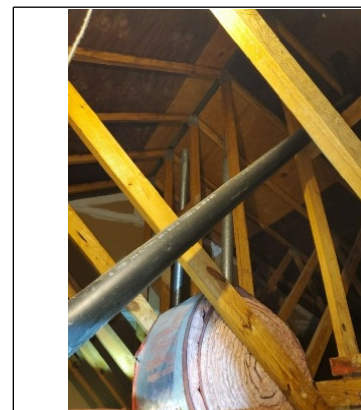
Evidence of prior roof repair

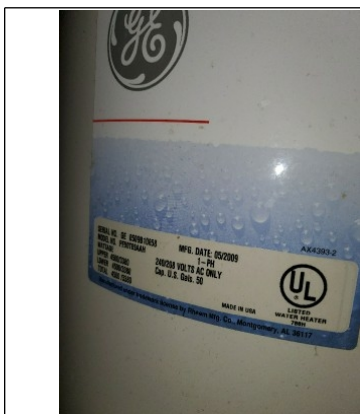
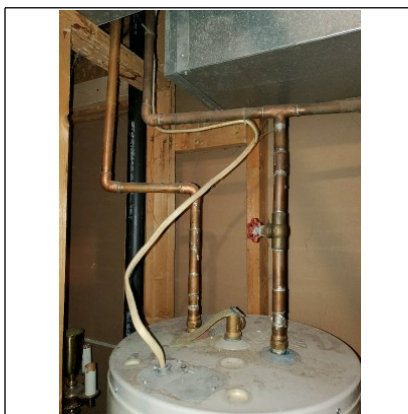
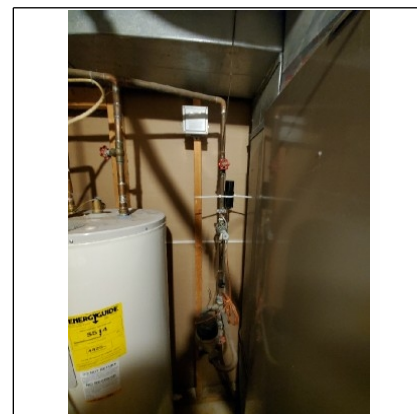
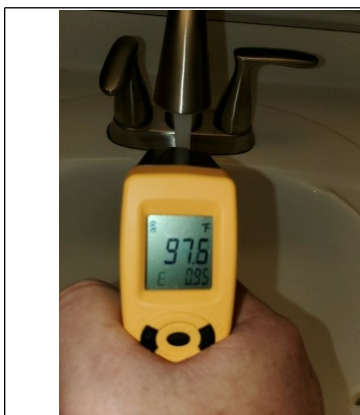
Water heater , 10 years old and well into its life expectancy. Showing rust at bottom of tank. Appliances are dated and may need replacement within near future.

Comments Water heater missing: pan installation, expansion tank, and pressure relief line directed to drainage source. Hot water tested throughout house at approx 97°. Unit is operating effectively.

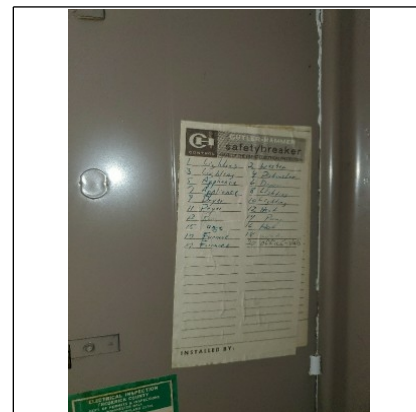
Branch wire condition ☒ Satisfactory ☐ Poor ☐ Recommend electrician evaluate/repair ☐ Romex ☐ BX cable
☐ Conduit ☐ Knob/Tube ☐ Double tapping ☐ Wires undersized/oversized breaker/fuse
☐ Panel not accessible ☐ Not evaluated
 Reason: Evidence of breakers and additional circuits added to panel since installation.

Red wiring indicates new circuits.
