Home Inspection Report

1542 Your Street, Your Town, MD 21701

Monday November 4, 2019

ALL YOURS HOME INSPECTION LLC
494 Windemere Dr.
Aberdeen, MD 21001
443-601-9715
ALLYOURSINSPECTIONS@GMAIL.com

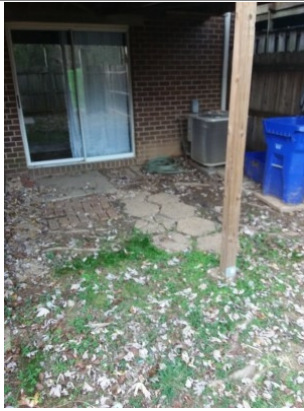
Rear lower patio consists of pavers and blocks. Normal settling has occurred. The area is complicated by a failing down spout and a negative grade from common area at the back of the property. Suggest review with HOA on this matter. See photo.

Patio seems settled due to water runoff from down spout in top right of photo. The extension on this down spout needs reattached.

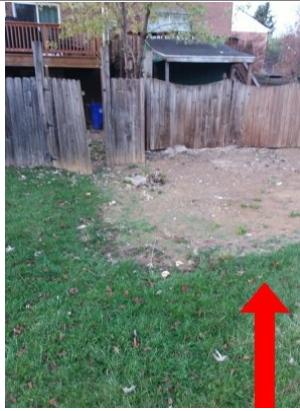
Evidence of pooling which is backing into property.

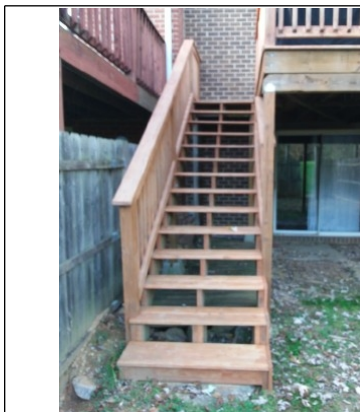
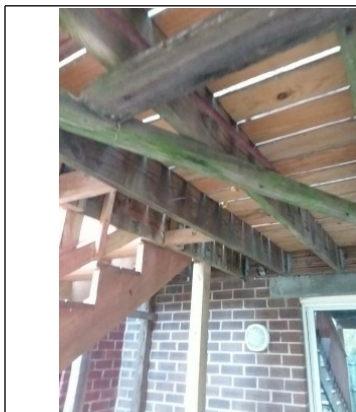
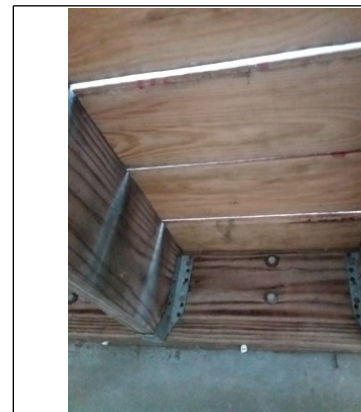
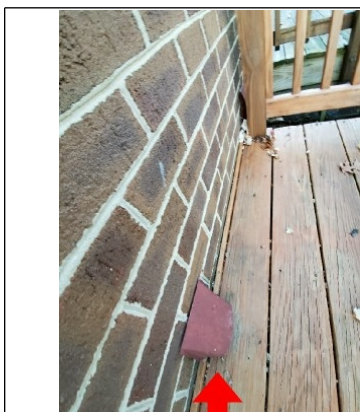
Comments While deck is in otherwise good condition, it was noted that the ledger board is not properly flashed and/or sealed to prevent moisture penetration. Additionally, it was noted that vents from the ground floor are discharging immediately on to the decking. See photos.

Vents discharging approx 2" from deck surface

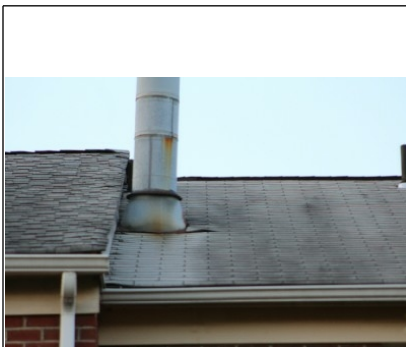
Evidence of prior leak and repair.

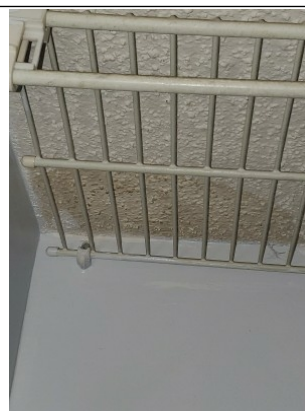
Comments Roof has several areas where wear, age, and damage are visible. Most notably, the rear East side at the meeting of the neighboring unit. There's a distinct line of curling shingles beginning at the fireplace flue and extending to the edge of the roof. There is evidence of moisture penetration at this point in the attic, and below that point in the ceiling of the master bedroom. See photos.

Following the leak, areas below moisture penetration in attic

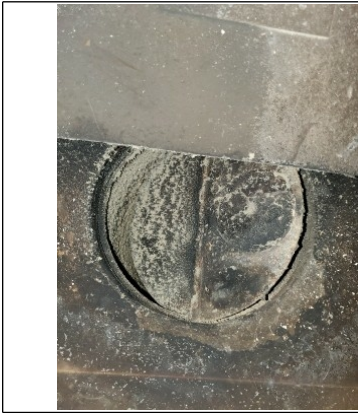
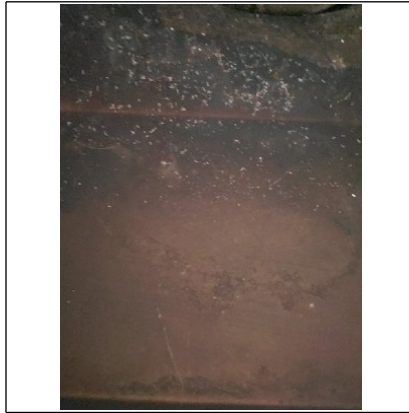
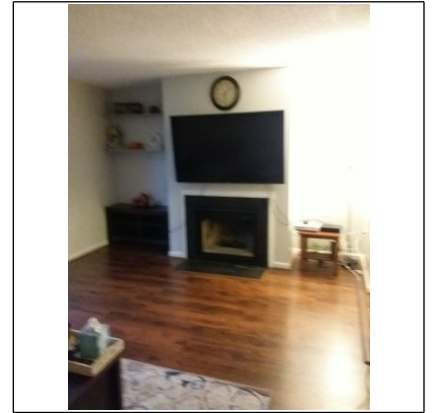
Comments Fireplace notvoperated in many years.

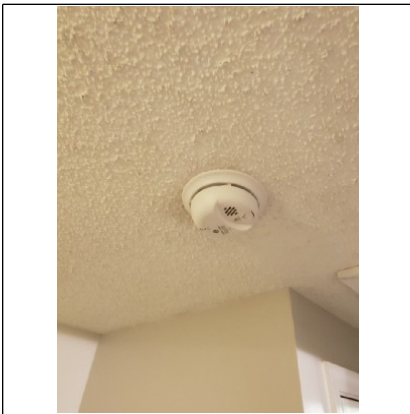
Smoke Detector ☒ Present ☐ Not Present Operable: ☐ Yes ☐ No ☒ Not tested ☐ Recommend additional
☒ Safety Hazard

CO Detector ☐ Present ☒ Not Present Operable: ☐ Yes ☐ No ☒ Not tested ☐ Recommend additional
☒ Safety Hazard

Comments Recommend replacement with ten year alarms on each floor.

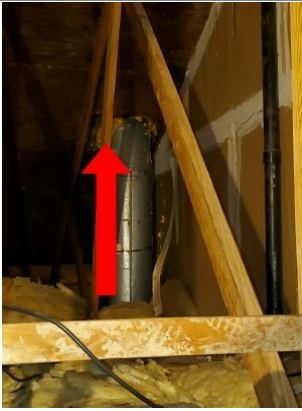
Comments Further attic photos in reference to leaks are in roof section. Roof sheathing shows multiple areas of prior repairs. Noted foaming applied around fireplace flew.

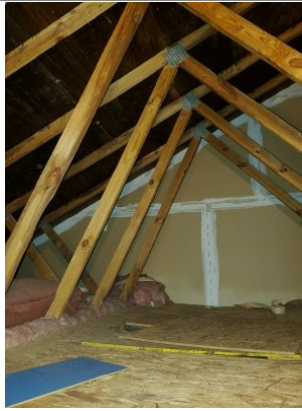
Handyman foam application
around fireplace flue

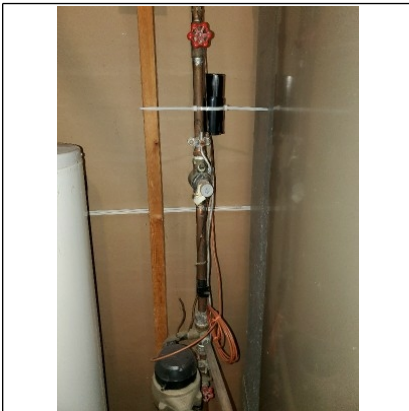
Comments Water heater missing: pan installation, expansion tank, and pressure relief line directed to drainage source. Hot water tested throughout house at approx 97°. Unit is operating effectively.

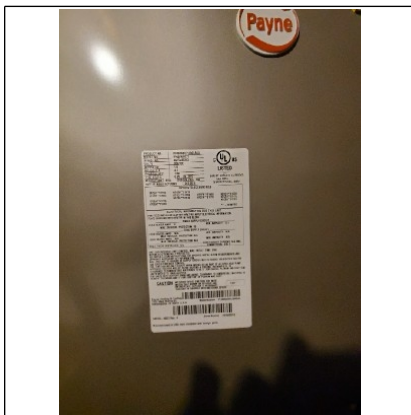
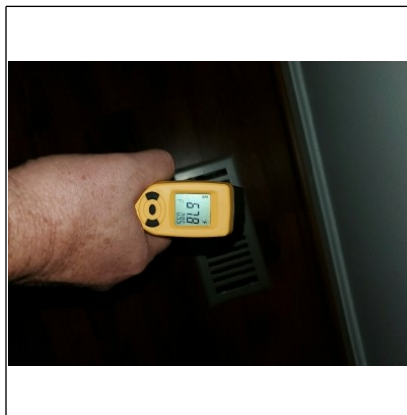
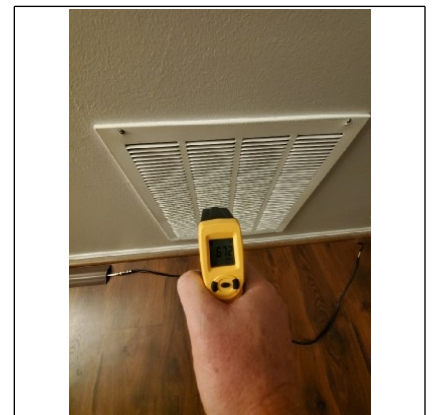
Comments Heating system tested with acceptable differential of 15 degrees. Cooling system tested with slightly less differential, possibly due to ambient temperature below 65 degrees.

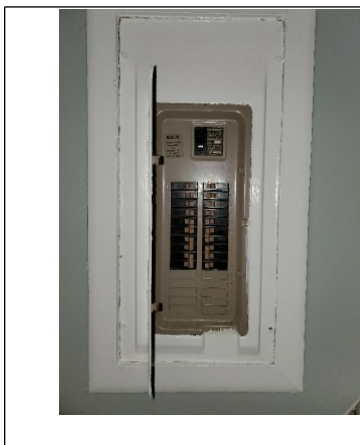
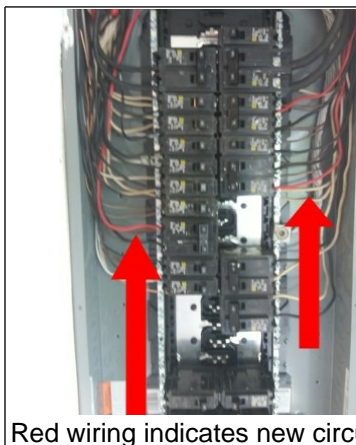
Red wiring indicates new circuits.

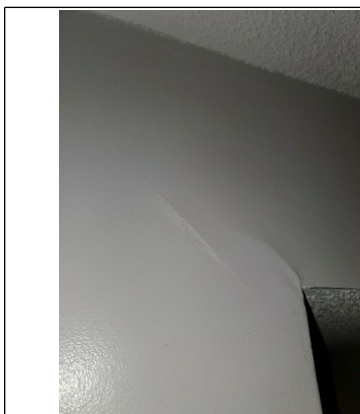
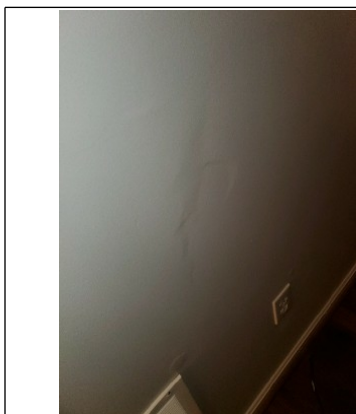
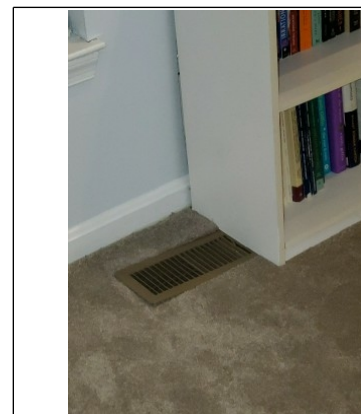
Comments Various irregularities in drywall throughout.
